Damage Detection of Rotating Machinery

A thesis submitted in partial fulfilment for
the degree of Doctor of Philosophy

Mechanics, Materials and Advanced Manufacturing Engineering
School of Engineering

2017

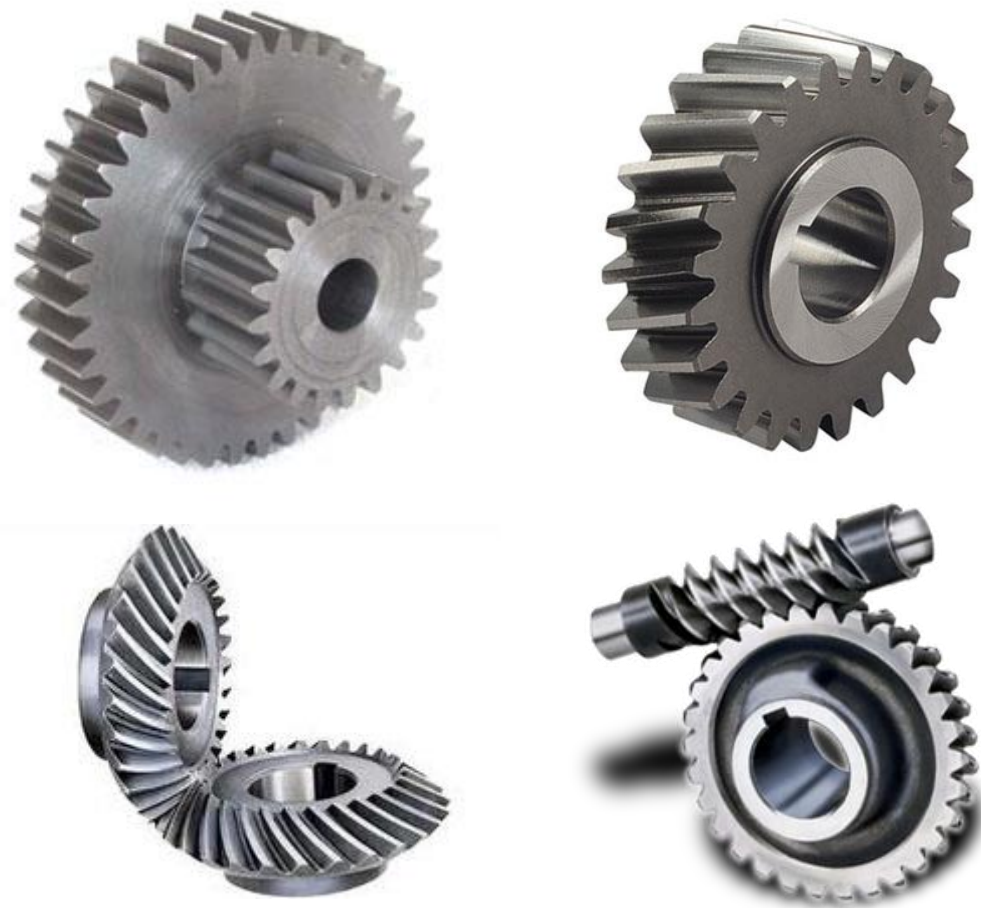
Figure 2-9 - Examples of gears; a) Spur Gear, b) Helical Gear, c) Bevel Gear and d) Worm Gear

Gears are often found within rotating machinery and as such, are an additional source within the signals produced at the bearing. Gears are used to facilitate the transmission of power and rotation from one shaft to another and are often paired together in ratios to increase/decrease both speed and torque depending on the application. As with bearings, gears come in a number of different designs and are capable of transmitting power between both parallel and perpendicular shafts. Common gear types, as pictured in Figure 2-9, include spur gears, helical gears, bevel gears and worm gears.

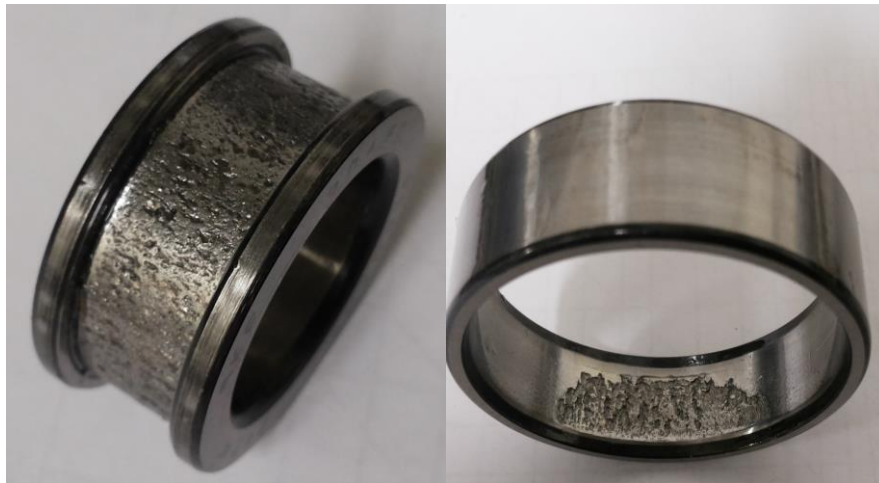
Figure 4-53 - Test bearing damage post-test

Figure 4-53 shows the extent of the damage observed on the inner and outer raceway upon being disassembled after a running period of 12 hours. The damage on the outer raceway is localised to the point of maximum load and it can be seen that the front face of the outer race as viewed in Figure 4-53 was overloaded through misalignment due to the shape of the damage area. The damage on the inner raceway covers over 270° of the bearing surface due to the point of maximum load on the inner raceway changing as the shaft, and hence inner race, rotates (with a fixed outer raceway). Despite such extensive damage occurring on each of the two raceways, there was no visible damage on any of the rollers.

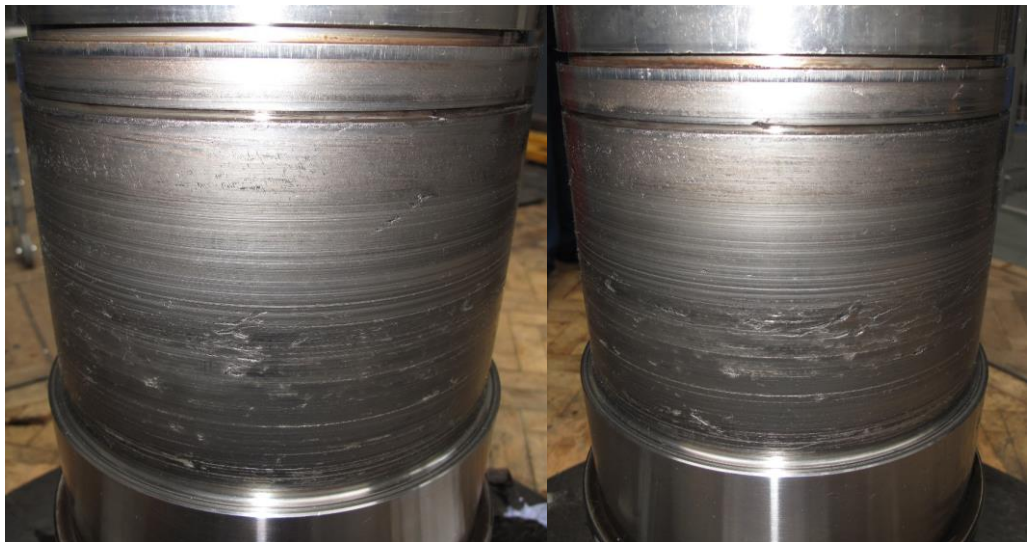
Figure 5-30 - Fretting damage of drive shaft after 120,000 revolutions

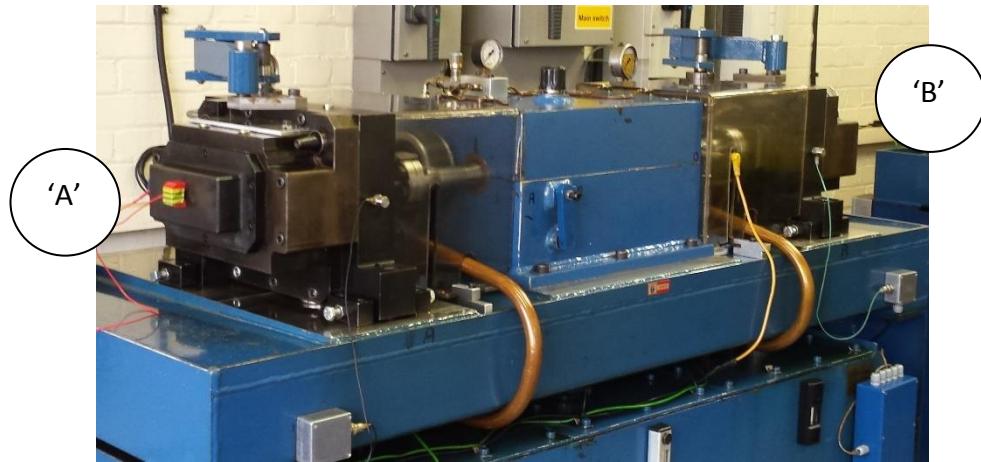
Figure 6-1 - Overview of the test rig

The back-to-back gear test rig, located within the Newcastle University Gear Design Unit, aims to test the surface fatigue of two pairs of spur/helical gears and is capable of operating with a maximum pinion speed of 6000rpm and a maximum wheel torque of 1400Nm. Figure 6-1 and Figure 6-2 provide an overview of the test rig with gear pair 'A' on the left-hand side, gear pair 'B' on the right hand side and a hydraulic, vane actuated torque unit located midway between them. A 30kW motor drives a belt attached to a pulley on the left side of the torque unit, close to gear pair 'A'. With a gear pair at each end, the test rig operates with a closed torque loop, recirculating the energy supplied by the motor. As a result, the motor is only required to compensate for any power losses, frictional and otherwise, within the loop.

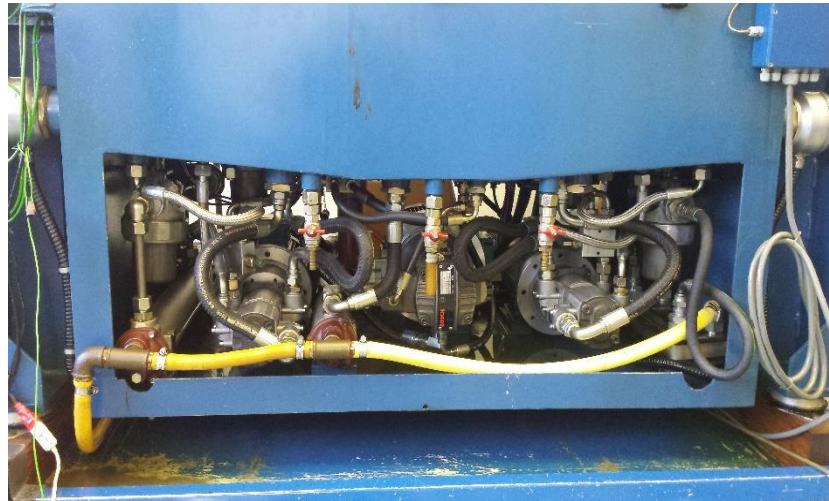
Figure 6-5 - Pumps and drive motors positioned below the test rig

Housed under the rig is the 3-phase motor that is coupled to the drive shaft via a drive belt and pulley wheels. The hydraulic system, comprising of hydraulic pumps, in-line oil filters, a heater/stirrer unit and oil sump, are all housed below the test rig and are required to produce the hydraulically applied torque to the gears pairs as well as providing both cooling oil and adequate lubrication to the gears and bearings (Figure 6-5). The drive motors and hydraulic pumps that are required to operate the test rig are all bolted to the main chassis of the test rig and, hence, it is possible that these may produce a large amount of ambient noise in both the AE and vibration data when the test rig is running.

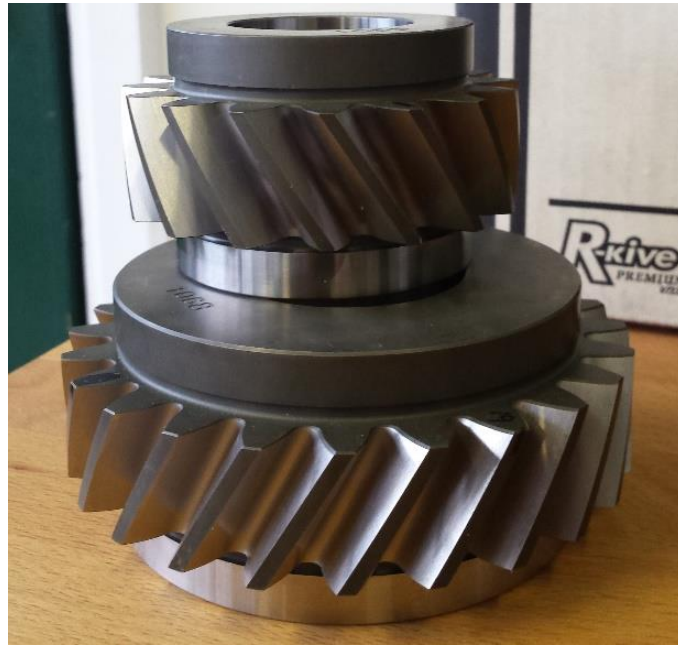
Figure 6-6 - Helical Gears under investigation

The primary function of the test rig, as previously mention, is to provide repeatable analysis of gear materials, and for this test schedule included the determination of the pitting characteristics of helical gears, Figure 6-6, when made from a novel steel alloy. The design specifications of the helical gears are summarised in Table 6-1. To increase the likelihood of pitting wear, the gears are designed to have a ratio of 1.5 as the gears have a common factor, causing the teeth to 'hunt' when running. Typical gear design aims for the gear ratio to be irrational as this decreases the occurrence of a tooth on one gear repeatedly meshing with only a few teeth on the other gear.

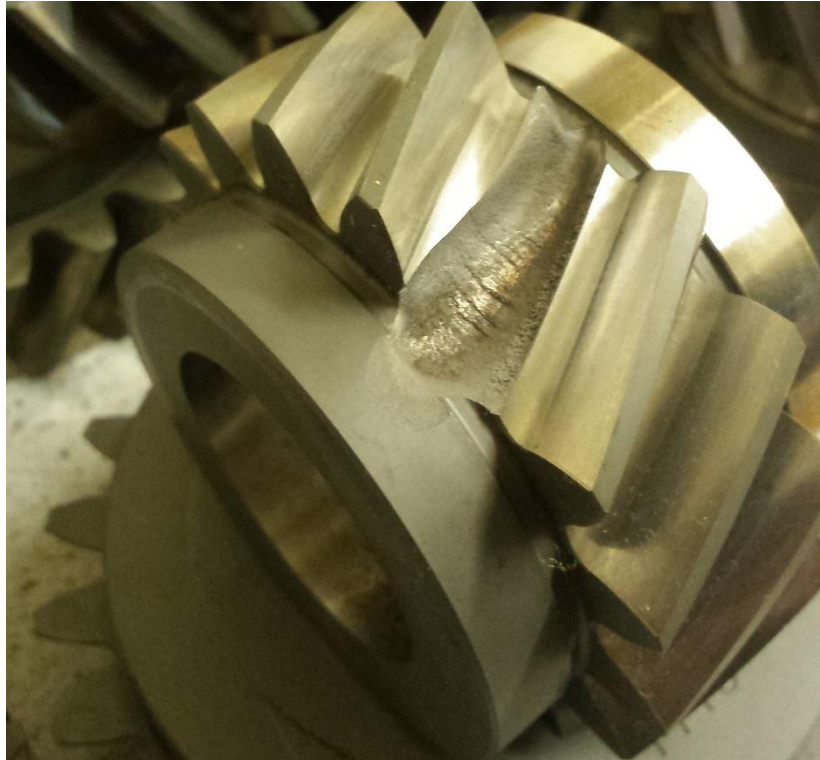
Figure 6-9 - Tooth break of Pinion gear 1098 after 1.7million revolutions on Flank B - Run 5
